Vestas[®]

Blade Services

Expert blade service solutions for all your turbines

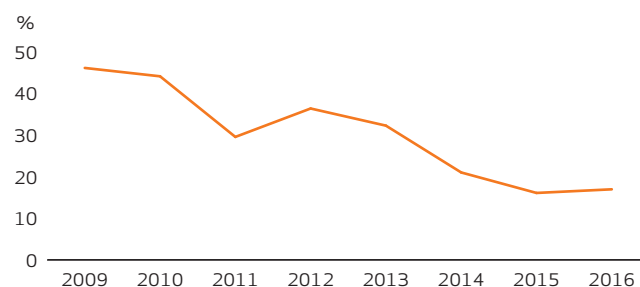
% of blade damage category 4 and 5

Full turbine stop due to blade repair has been reduced by 30 percent from 2009 to 2016 at turbines taken over by Vestas services.

Addressing damages as early as possible in the least serious damage classifications is the key to reducing blade repair costs. We recommend our partners to always repair damaged blades as early as possible. In doing so, we have in example seen the number of damages requiring turbine downtime reduced by 30 percent from 2009 to 2016.

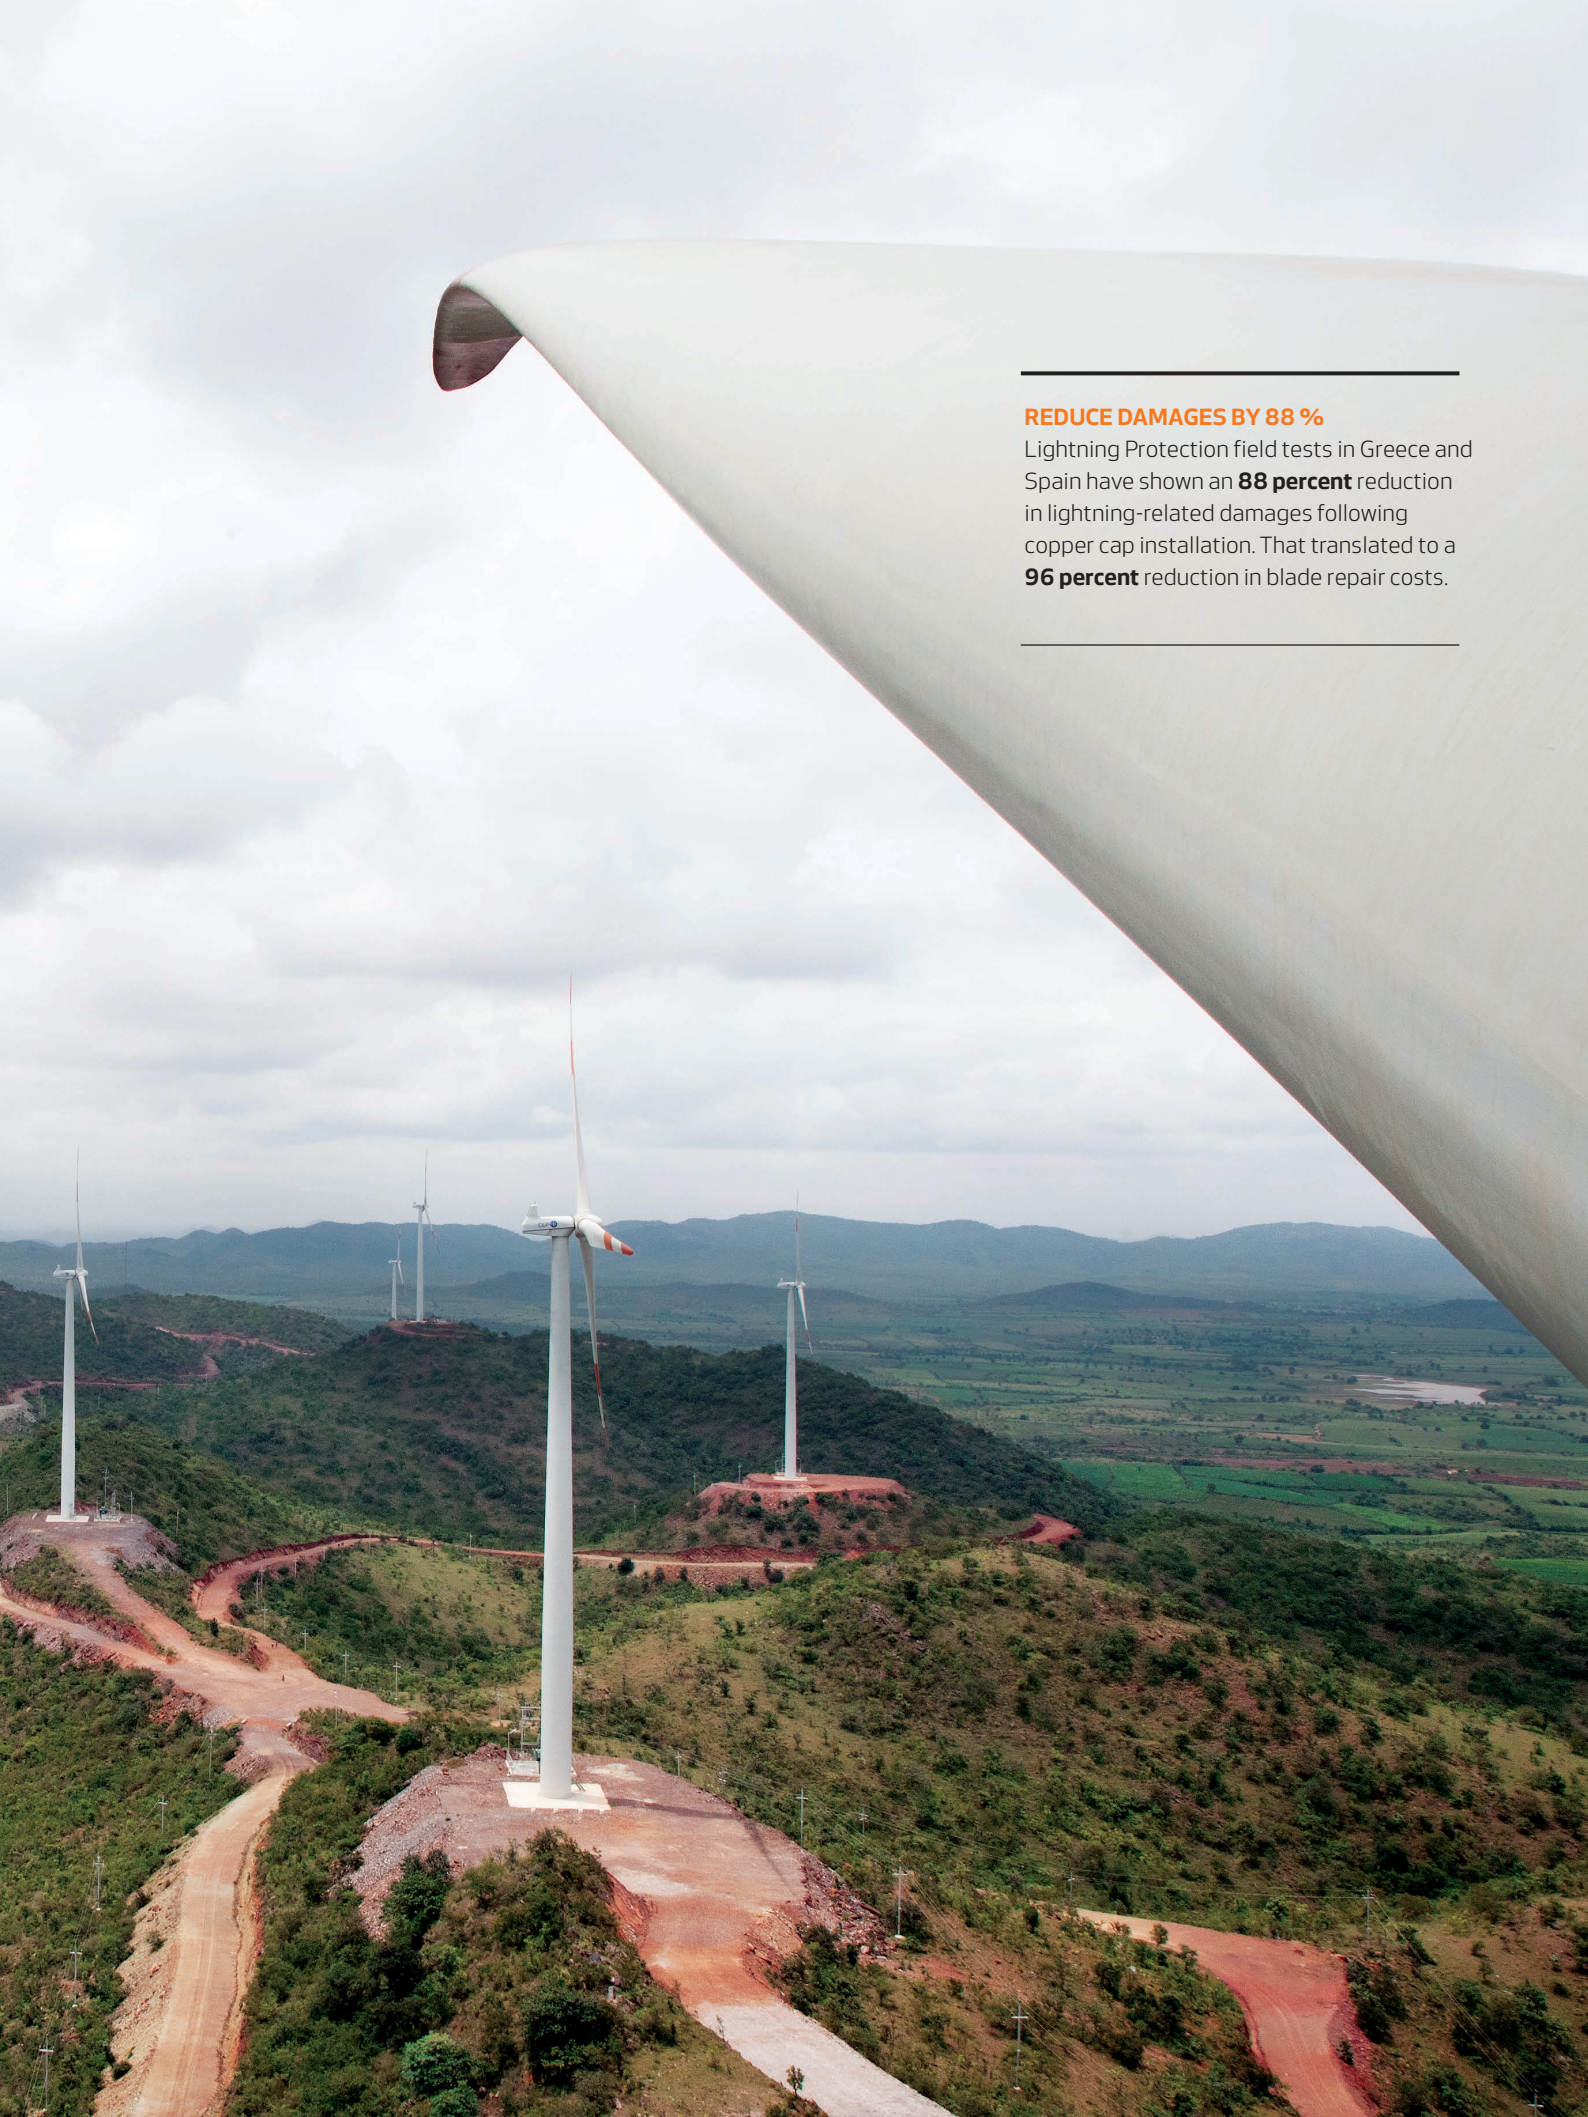
Copper strip

Lightning Protection field tests in Greece and Spain have shown an **88 percent** reduction in lightning-related damages following copper cap installation. That translated to a **96 percent** reduction in blade repair costs.

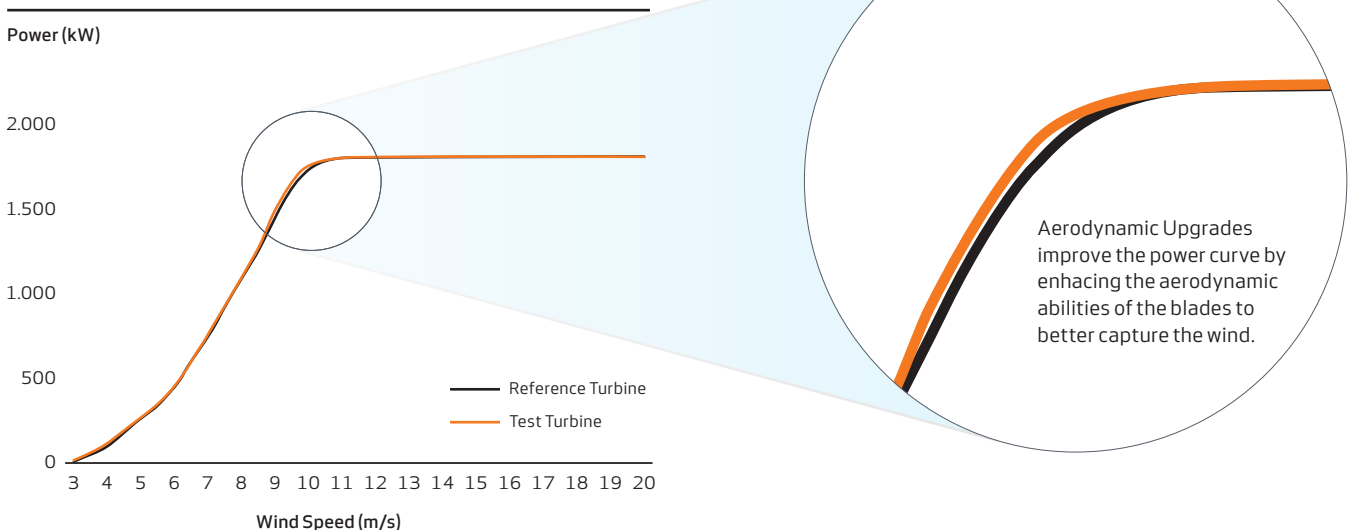
Figure 4: Aerodynamic Upgrades improve the power curve on the slope, delivering up to 2 percent* increase in annual energy production.

Our Aerodynamic Upgrades provide the latest development in wind turbine blade technology to increase your fleet's profitability. Vortex Generators and Gurney Flaps optimise the blade's ability to capture the wind.
